# WHAT HAPPENED IN FUKUSHIMA - A TECHNICAL PERSPECTIVE

The Nuclear Accidents at the Mark 1  
Boiling Water Reactors (BWR)  
at Fukushima Daiichi Units 1 - 4  
and Implications for American BWR

LBNL EETD noon Seminar - April 5, 2011

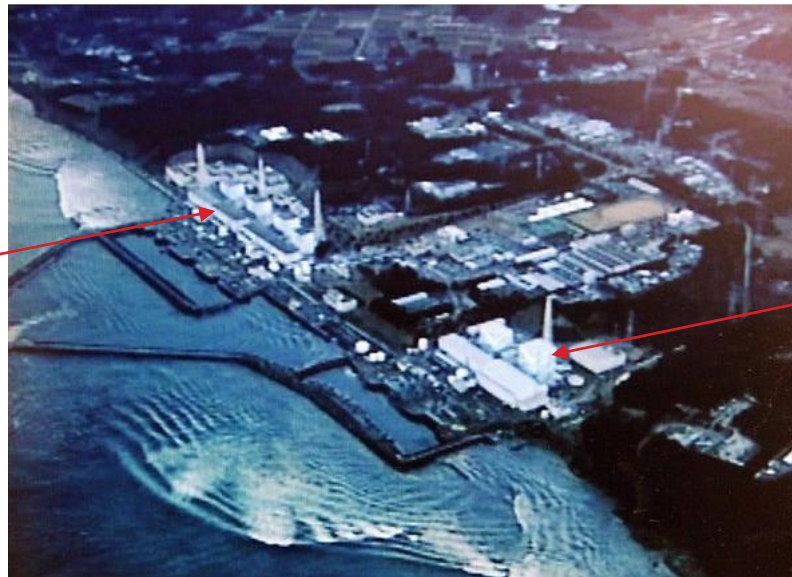
15:41 Local Time: **14 m (40 ft) Tsunami** hits. Plant designed only for 6.5 m Tsunami

Units 1, 2, 3, 4  
(#4 in Outage)

Units 5 & 6  
(in Outage)

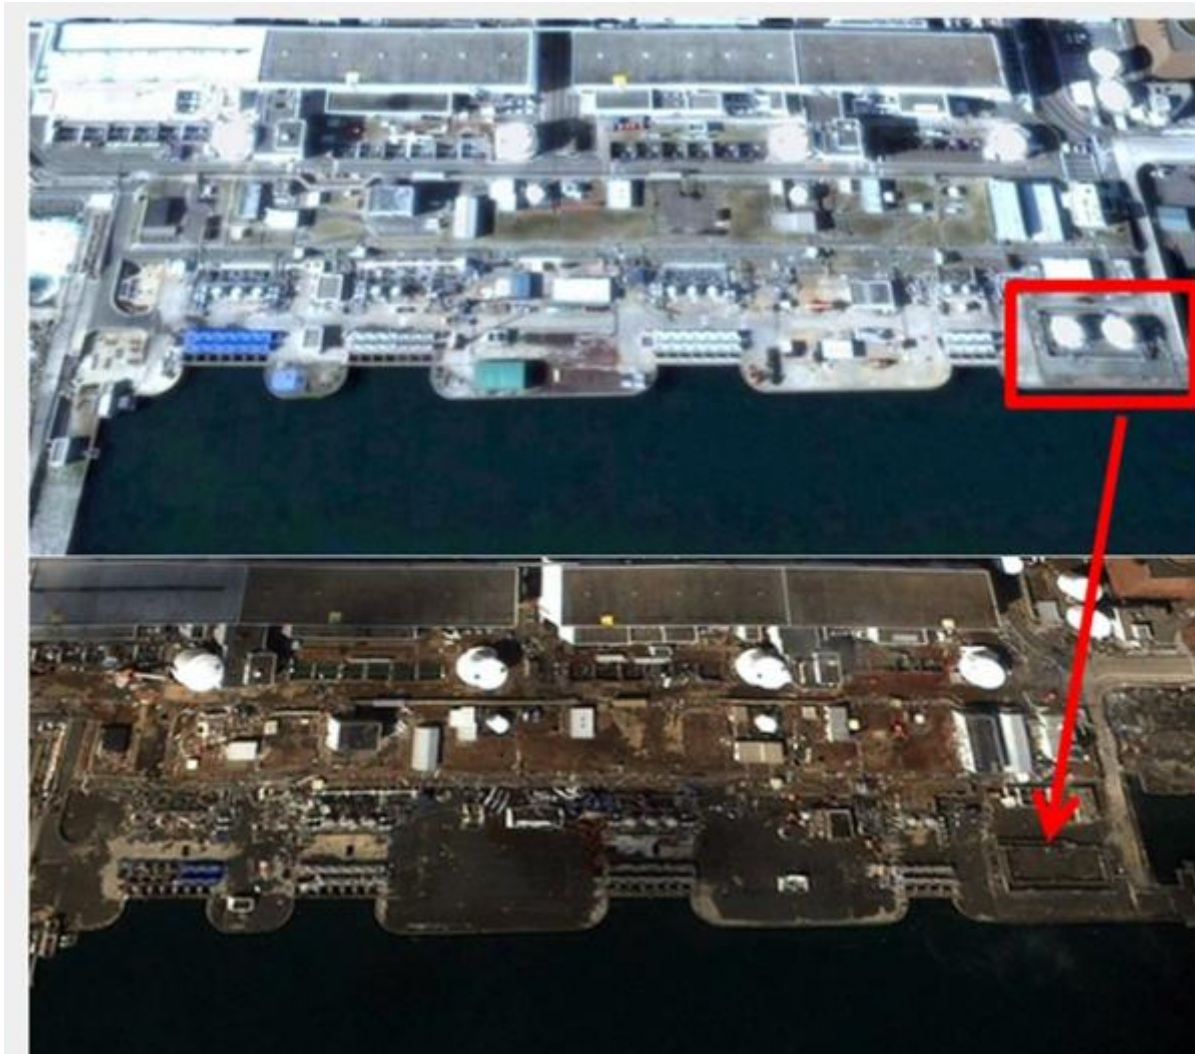
Loss of Diesel  
Tanks for  
Emergency  
Generators

+ Potential  
Flooding of  
the 14 Diesel  
Generators

Before Tsunami

After Tsunami

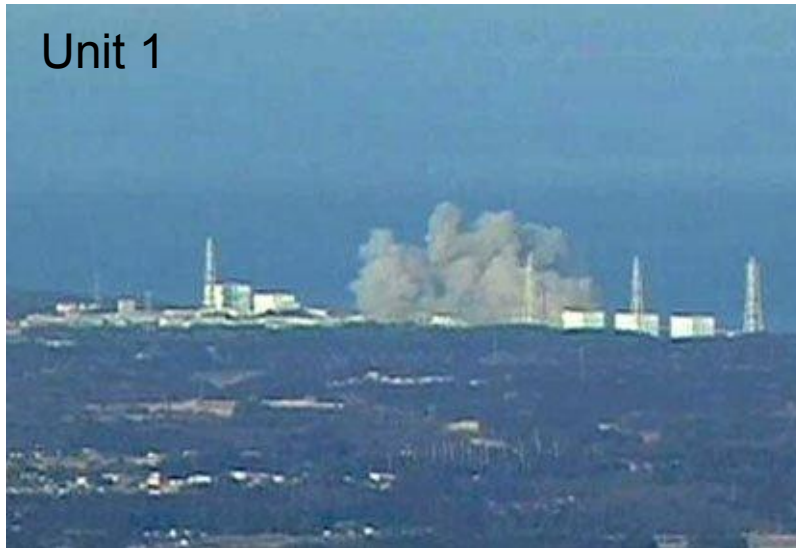
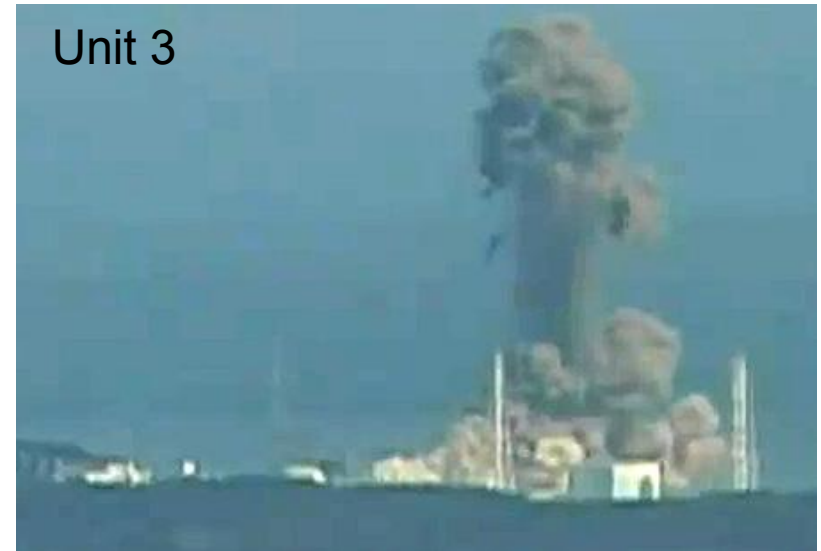
**Hydrogen Explosions** of outer Secondary Containment Buildings  
(Primary Containments Believed to be Undamaged at that Time)

March 12

Unit 1

March 14

Unit 3

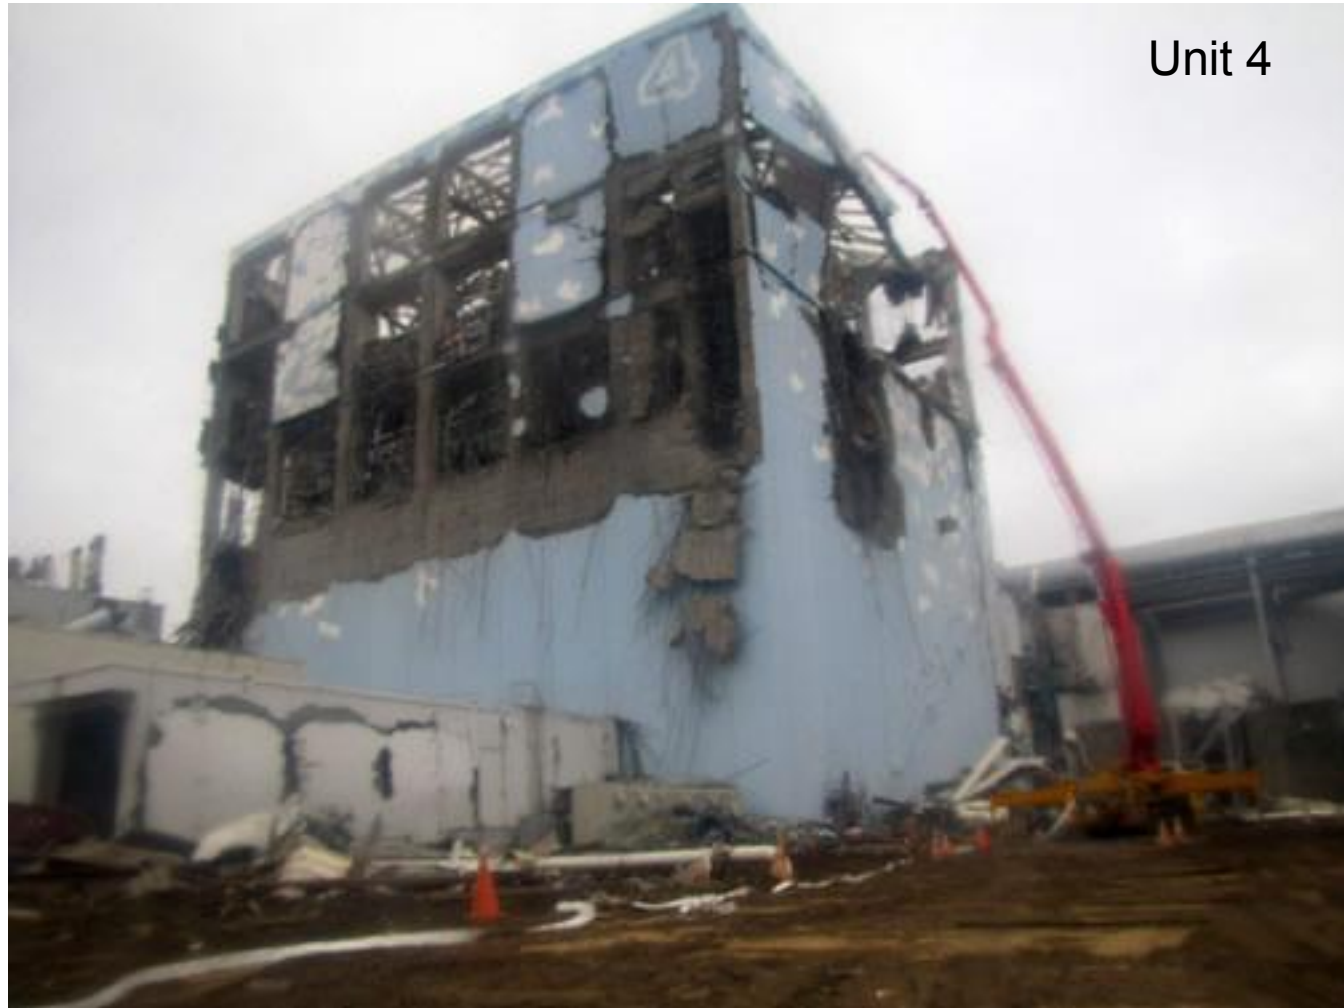
Truck-mounted  
concrete pump  
160 m<sup>3</sup> water /h

Unit 4

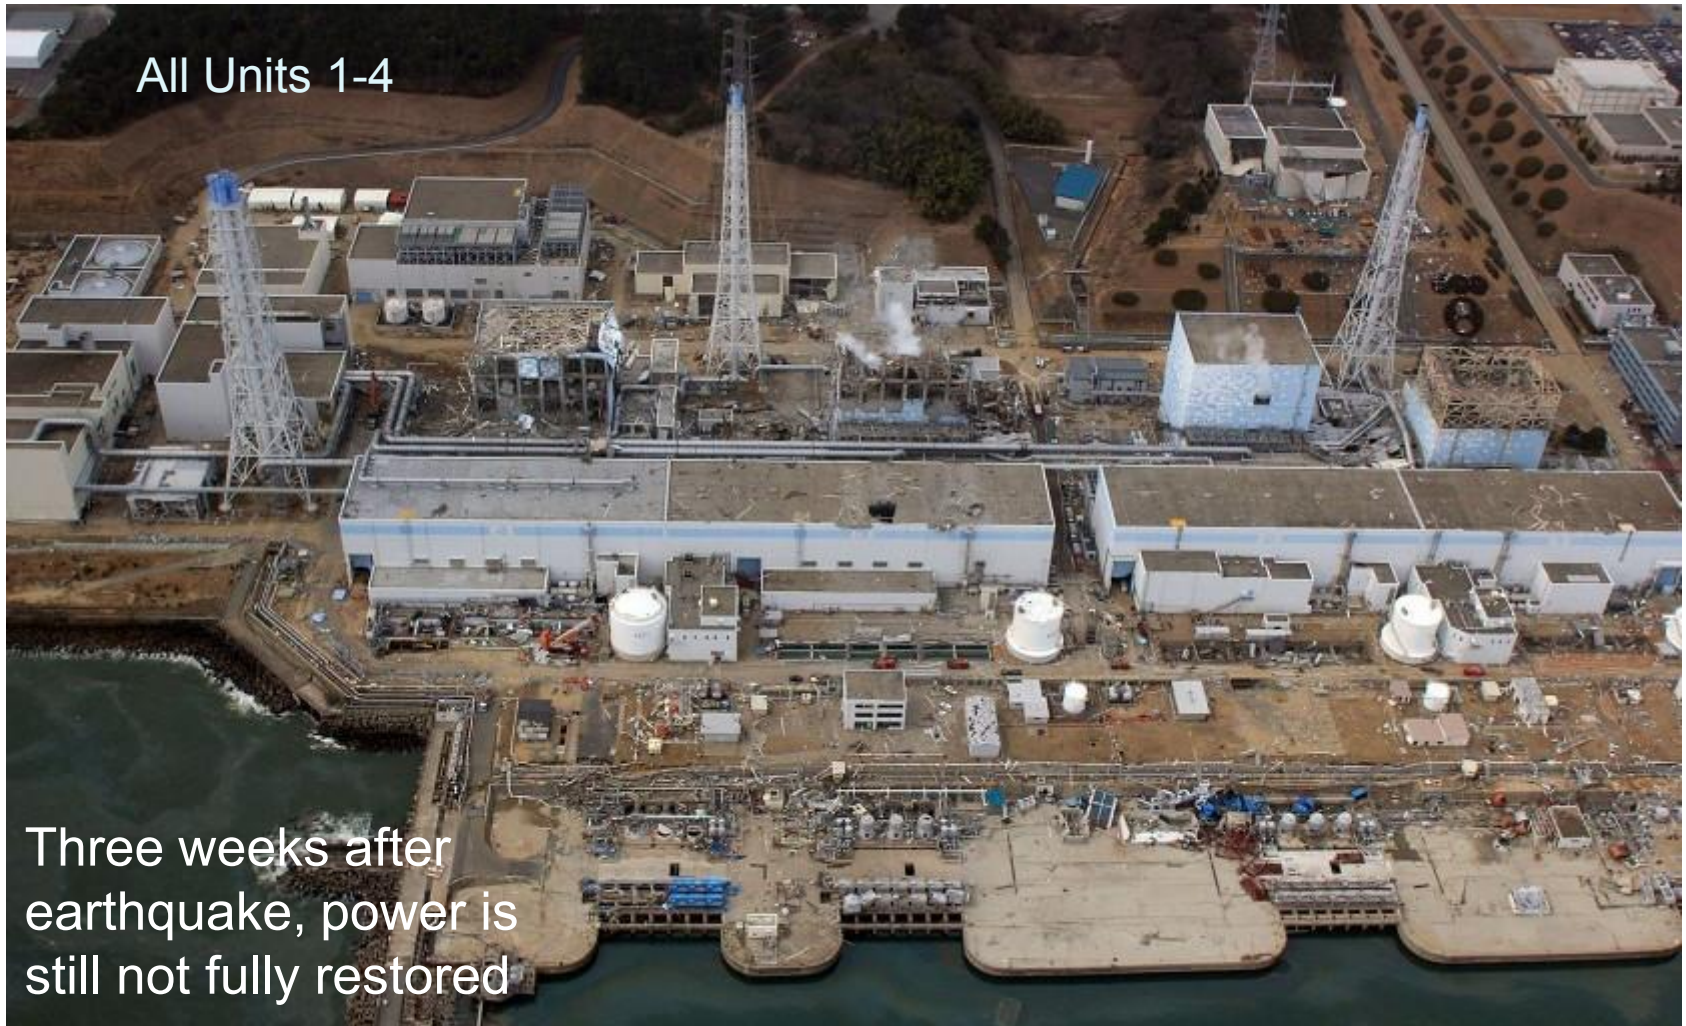
All Units 1-4

Three weeks after  
earthquake, power is  
still not fully restored
